STAFF SUBMITTAL

Application for Stream Channel Alteration Permit (SCAP.3528.2)
Streambank Stabilization, Moloa'a Stream
Declaratory Ruling No. DEC-ADM12-01
Moloa'a, Kauai (TMK: (4) 4-9-014:021)

Application for Stream Channel Alteration Permit (SCAP.3528.2), to reinforce and stabilize streambank, Moloa'a Stream, Moloa'a, Kauai (TMK: (4) 4-9-014:021).

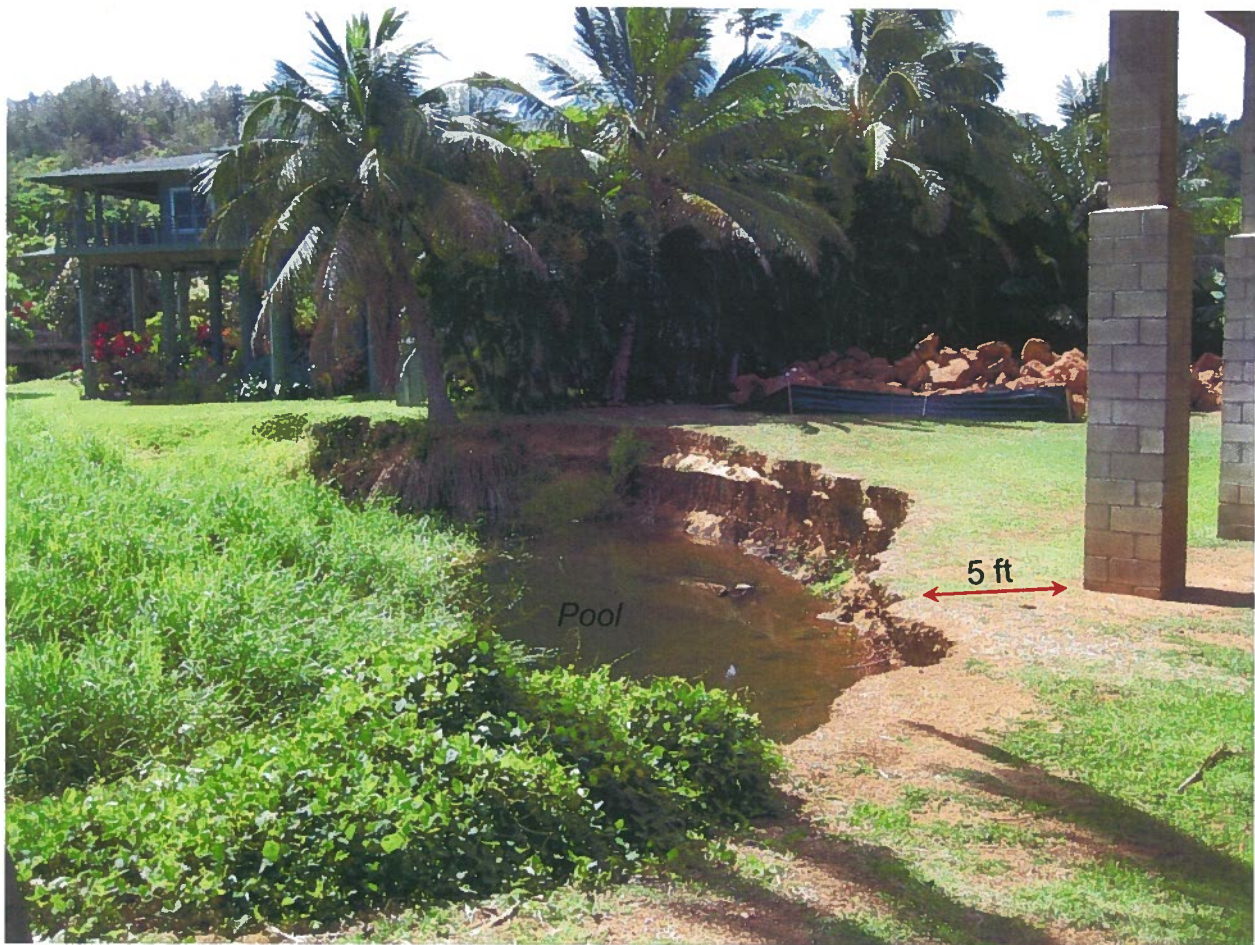
In the vicinity of the applicant's property, the vertical, 5 to 6 ft high bank is composed of unconsolidated, fine-grained alluvium and interfingering sand deposits and at the time of the site visit the water in the pool adjacent to the cutbank was approximately 5 ft deep (Exhibits 4 and 5). The unconsolidated sediments overlie limestone bedrock that, in the vicinity of the property, forms a gently sloping, approximately 6 ft wide, bench with a vertical drop-off into the pool (Exhibits 4 and 5). A photograph submitted by the applicant, taken prior to the March 2012 storm event shows a heavily vegetated bankline with a vertical face (Exhibit 6).

Exhibit 4: Left bank of Moloa`a Stream, Kauai, looking upstream (9AM August 20, 2012 staff site visit), showing pier adjacent to streambank.

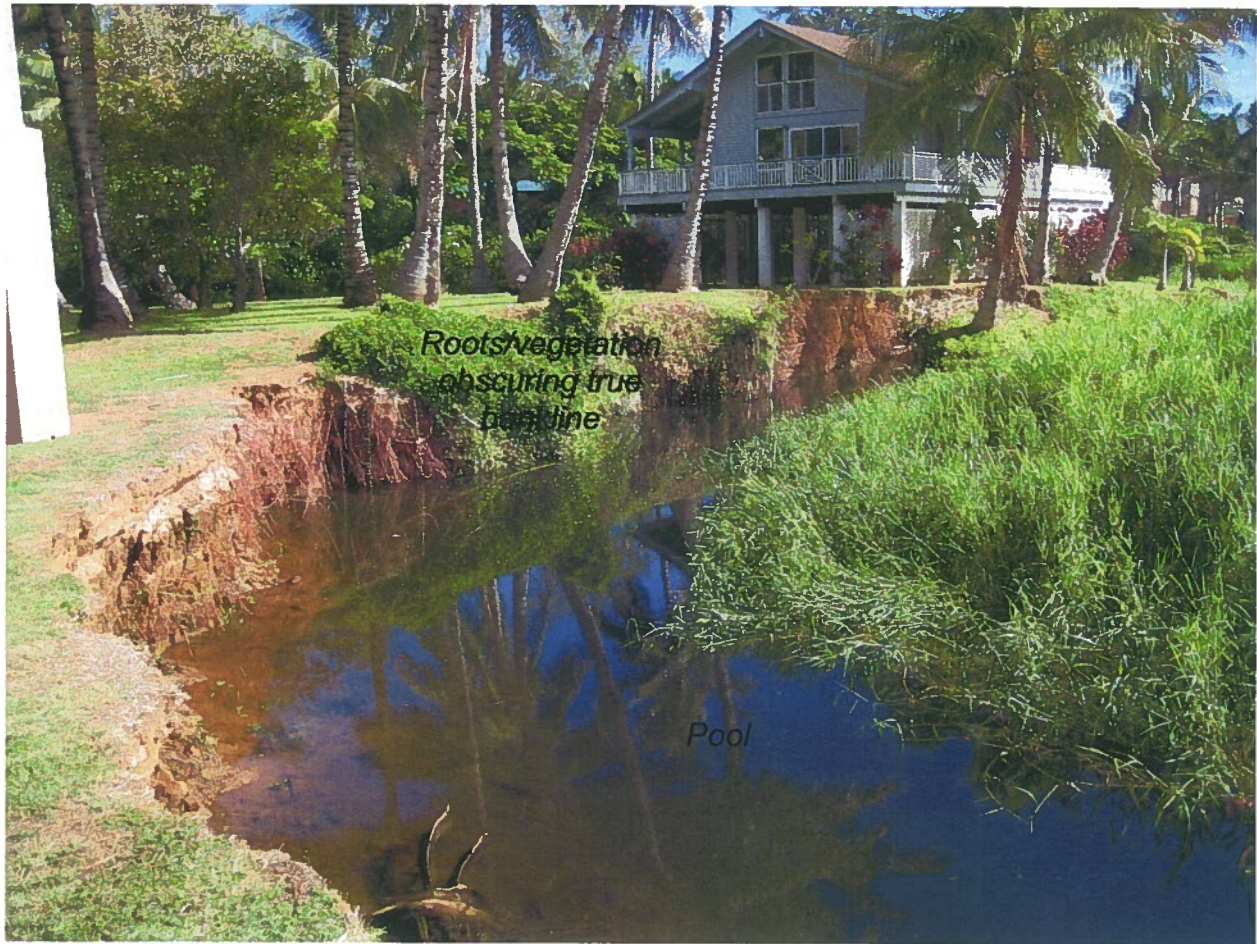
Exhibit 5: Left bank of Moloa'a Stream, Kauai, looking downstream (9AM August 20, 2012 staff site visit).

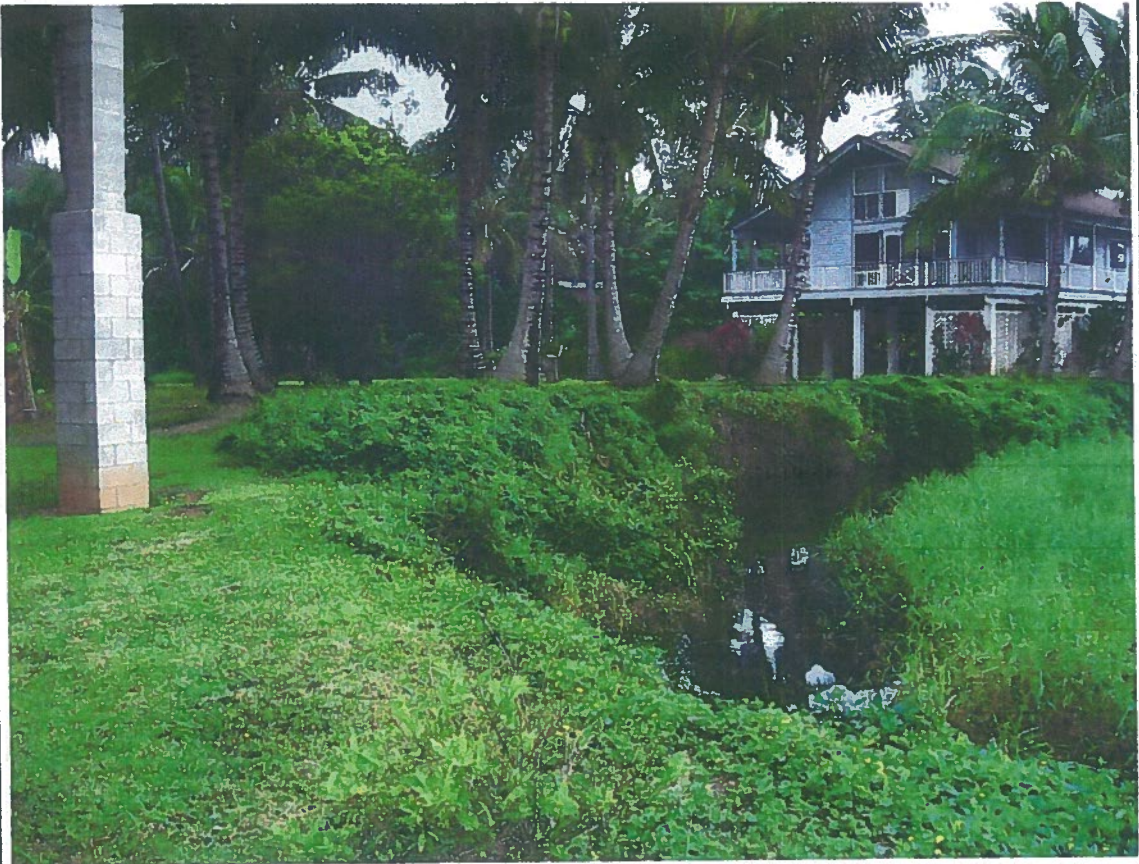
Exhibit 6: Moloa`a Stream crossing applicant's property prior to March 2012 storm event.

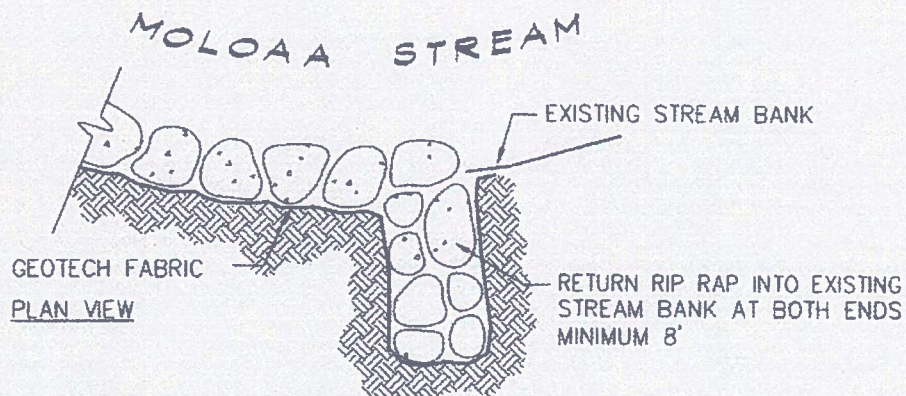
6. The applicant does not explain where the excavations necessary to return the rip rap into the stream bank will be located or the amounts of materials involved (Exhibit 8).

TYPICAL END RETURN DETAIL

Exhibit 8: Schematic plan of rip rap end return.

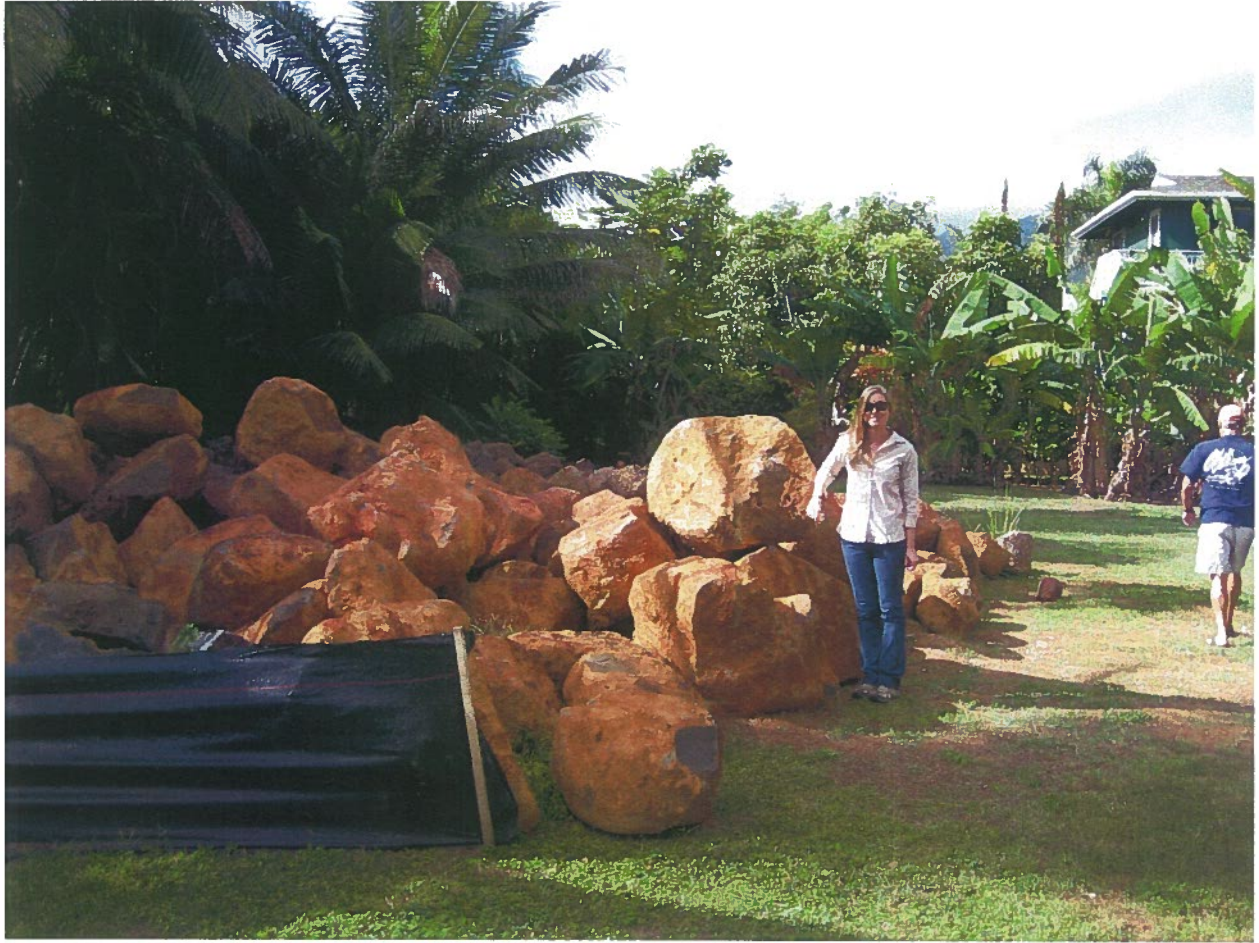
1. The size of the rip rap is variously described as 18 inch diameter and 18 inch minimum.
2. Boulders that it is proposed be used to armor the bank on the applicant's property have already been delivered to the site (Exhibit 9). The quantity in evidence greatly exceeds the 200 cubic yards specified in the application for a Stream Channel Alteration Permit, approximately half of the boulders in evidence greatly exceed 18 inches in diameter.

Exhibit 9: Boulder rip rap on site (5 ft 6 inch high person for scale, 9AM August 20, 2012 staff site visit).
